NASA/TM—2004-212303

# Durability Assessment of Gamma TiAl— Final Report

Susan L. Draper, Bradley A. Lerch, J. Michael Pereira, and Kazuhisa Miyoshi  
Glenn Research Center, Cleveland, Ohio

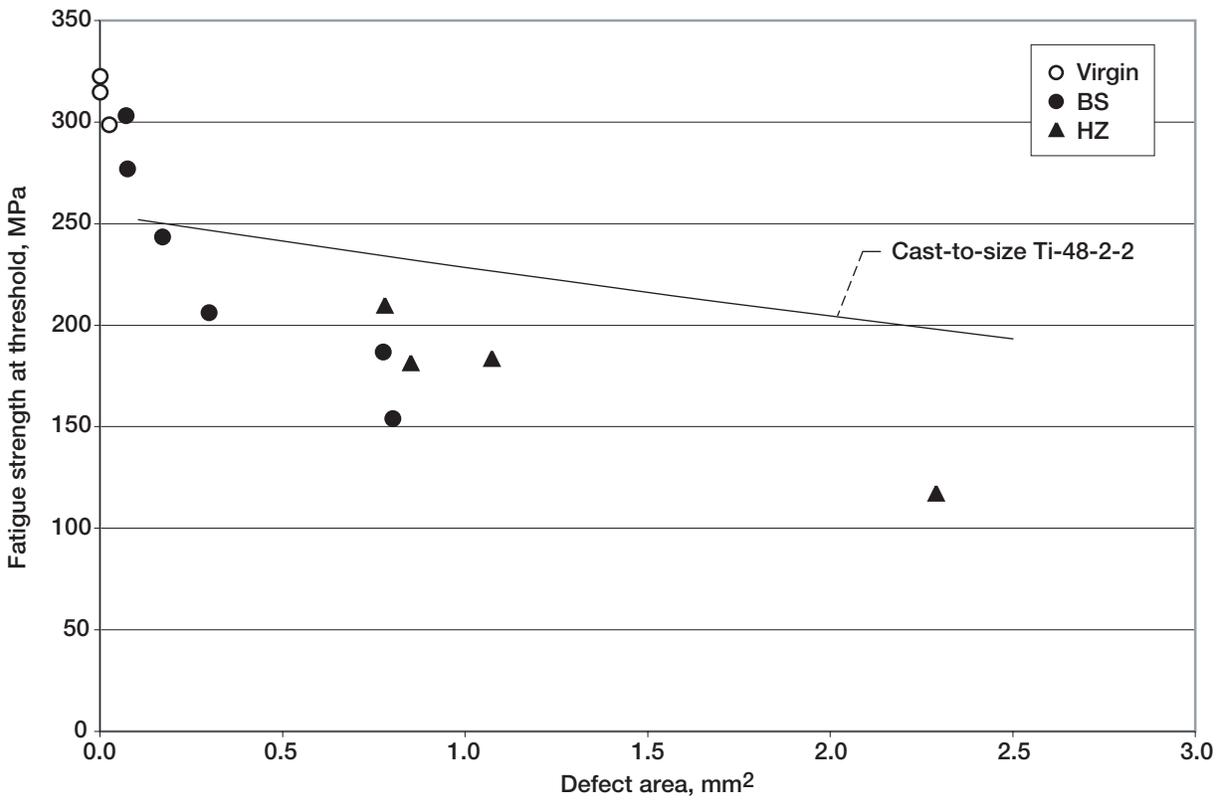
Figure 57.—Fatigue strength at threshold as function of defect area for machined 95A.

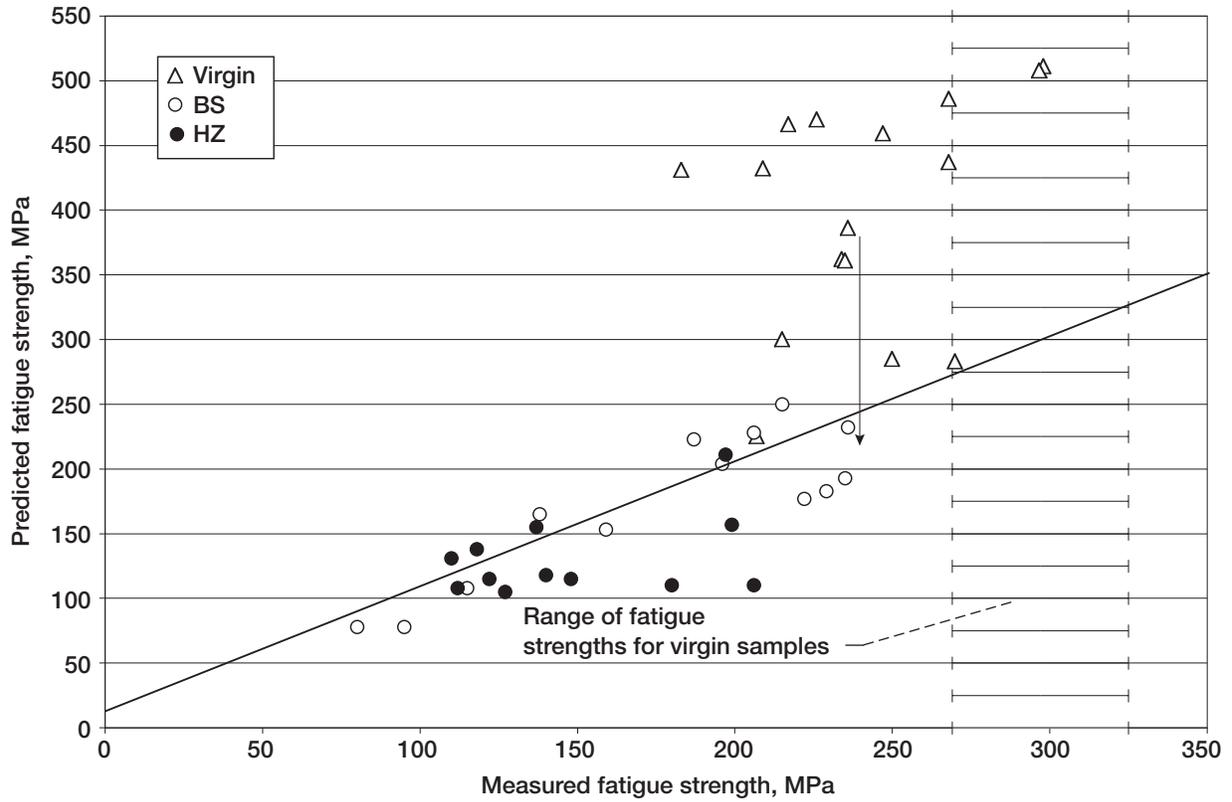
Figure 58.—Fatigue strengths predicted from equation (3) compared with measured fatigue strengths for cast-to-size Ti-48-2-2. Temperature was 650 °C; load ratio  $R_{\sigma}$ , 0.05; and estimated stress intensity  $K_{th}$ , 8.8  $\text{MPa}\sqrt{\text{m}}$ .

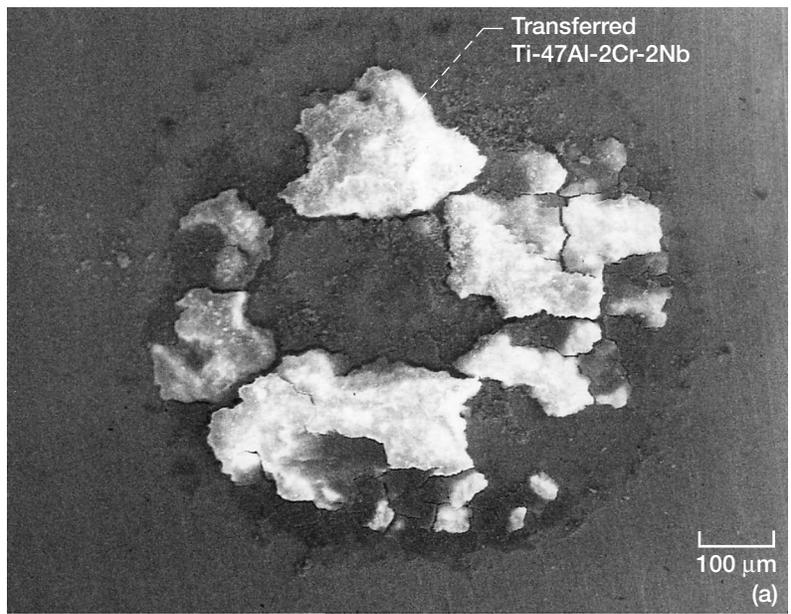
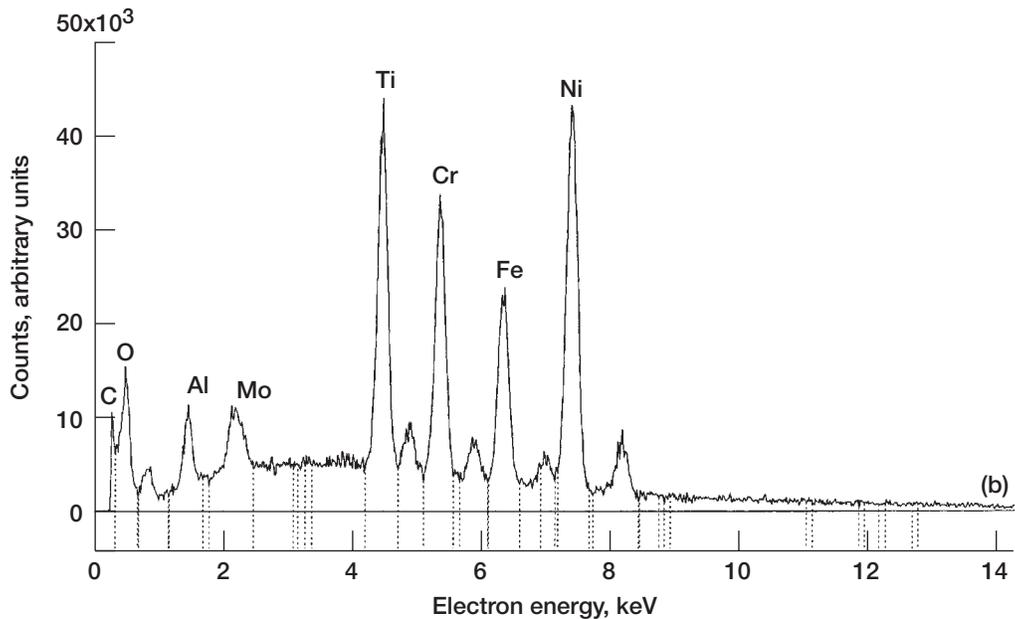
Figure 66.—Wear scar on IN718 pin fretted against Ti-47-2-2 flat. Fretting conditions: load, 1.5 N; frequency, 80 Hz; slip amplitude, 50 μm; total number of cycles, 1 million; environment, air; and temperature, 550 °C. (a) Scanning electron microscopy back-scattered electron image. (b) X-ray energy spectrum with energy dispersive spectroscopy.

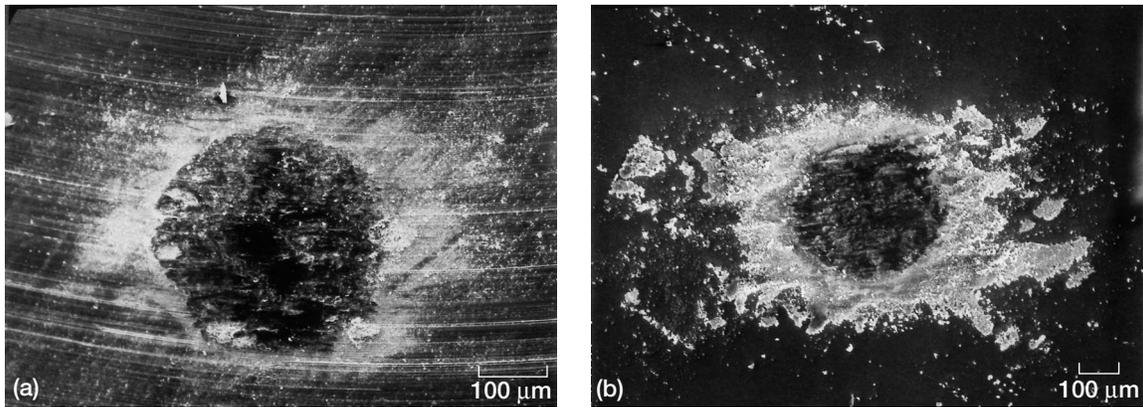
Figure 67.—Wear scars on (a) Ti-47-2-2 pin and (b) IN718 flat. Fretting conditions: load, 1 N; frequency, 80 Hz; slip amplitude, 50  $\mu\text{m}$ ; total number of cycles, 1 million; environment, air; and temperature, 550  $^{\circ}\text{C}$ .

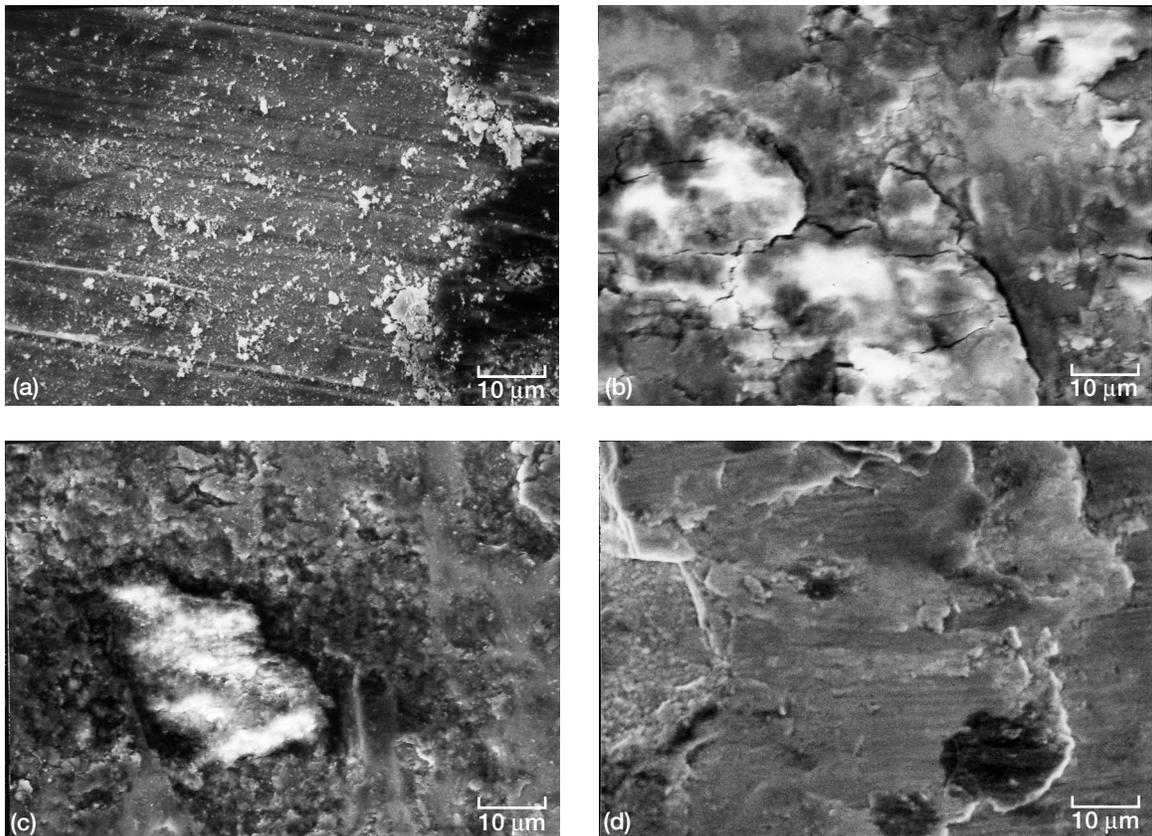
Figure 68.—Surface and subsurface damage in Ti-47-2-2 flat in contact with IN718 pin. Fretting conditions: environment, air; temperature, 550  $^{\circ}\text{C}$ ; load, 1 N; frequency, 80 Hz. (a) Scratches; slip amplitude, 50  $\mu\text{m}$ ; total number of cycles, 1 million. (b) Cracks in oxide layers; slip amplitude, 60  $\mu\text{m}$ ; total number of cycles, 10 million. (c) Cracks in oxide layers; slip amplitude, 50  $\mu\text{m}$ ; total number of cycles, 1 million. (d) Fracture pits and plastic deformation; slip amplitude, 70  $\mu\text{m}$ ; total number of cycles, 20 million.

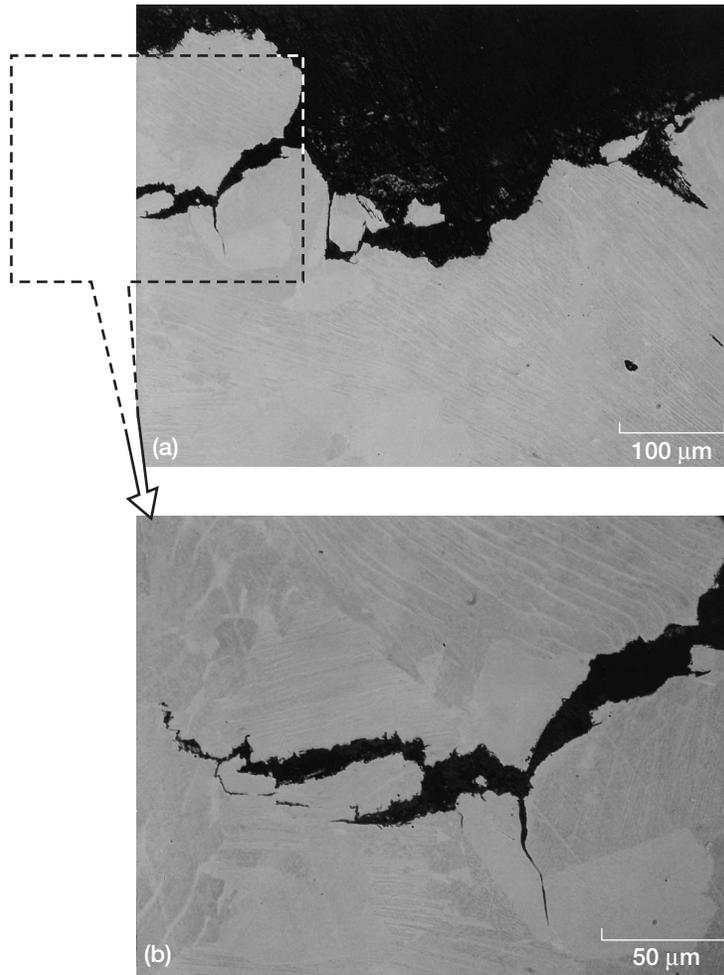
Figure 69.— Cross section of wear scar on Ti-47-2-2 flat in contact with IN718 pin. Fretting conditions: load, 30 N; frequency, 80 Hz; slip amplitude, 70  $\mu\text{m}$ ; total number of cycles, 20 million; environment, air; and temperature, 550  $^{\circ}\text{C}$ . (a) Overview. (b) Crack growth.

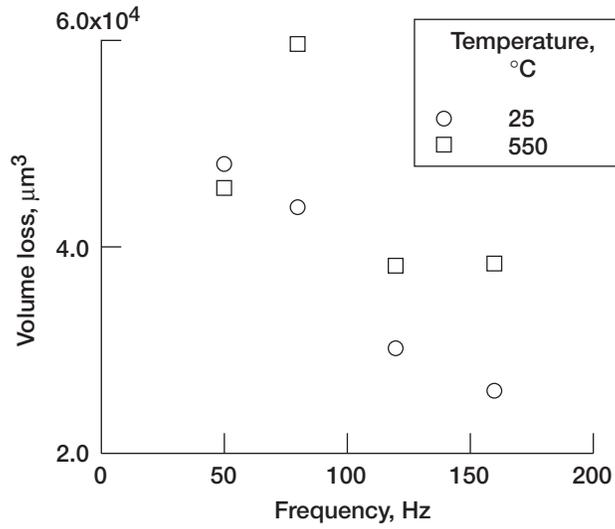
Figure 70.—Wear volume loss of Ti-47-2-2 flat in contact with IN718 pin in air as function of fretting frequency. Fretting conditions: load, 30 N; slip amplitude, 50  $\mu\text{m}$ ; total number of cycles, 1 million; environment, air; and temperatures, 25 and 550 °C.

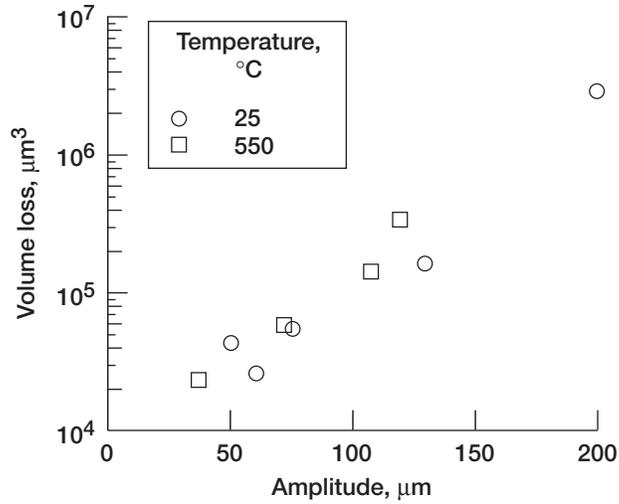
Figure 72.—Wear volume loss of Ti-47-2-2 flat in contact with IN718 pin in air as function of slip amplitude. Fretting conditions: load, 30 N; frequency, 50 Hz; total number of cycles, 1 million; and temperatures, 25 and 550  $^{\circ}\text{C}$ .

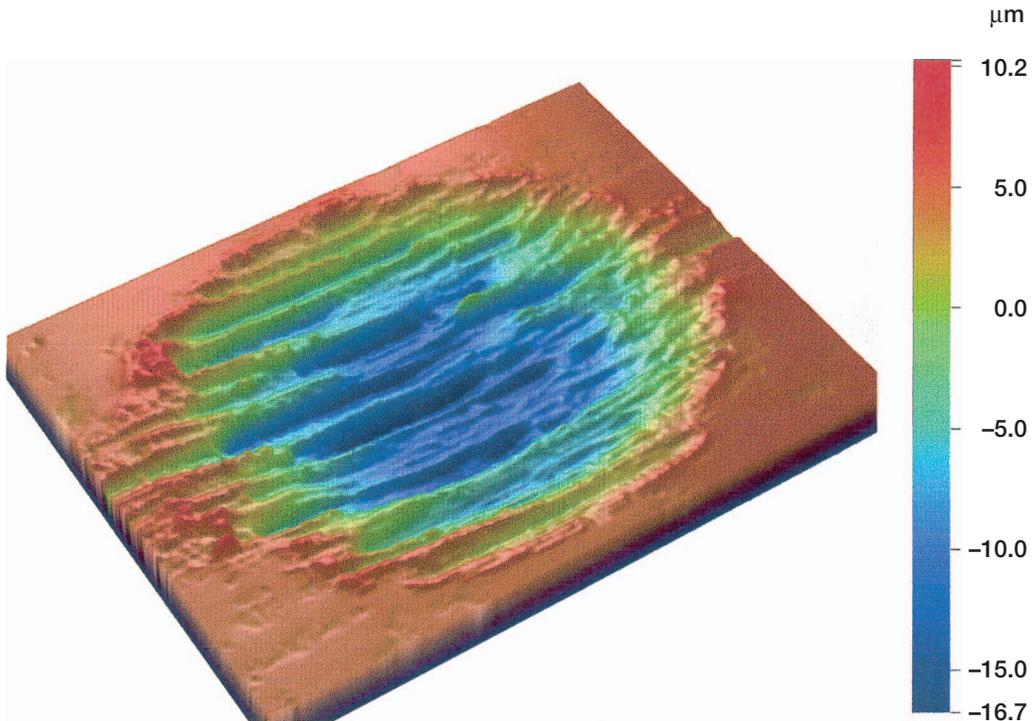
Figure 73.—Wear scar, showing scratches, on Ti-47-2-2 flat in contact with IN718 pin. Fretting conditions: load, 30 N; frequency, 50 Hz; slip amplitude, 200  $\mu\text{m}$ ; total number of cycles, 1 million; and temperature, 25  $^{\circ}\text{C}$ .

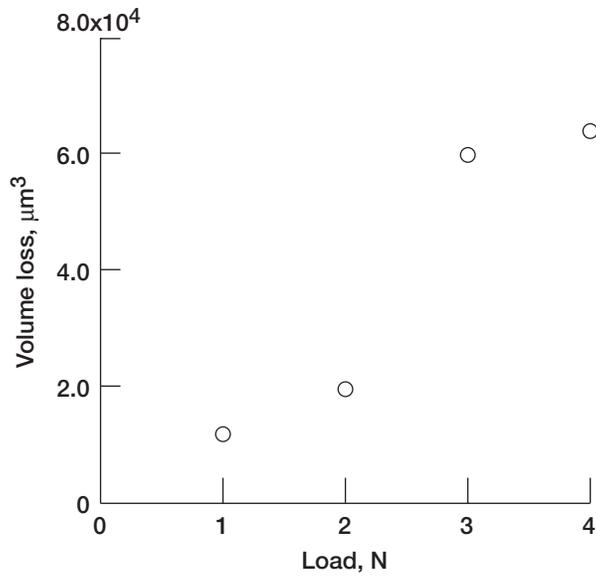
Figure 74.—Wear volume loss of Ti-47-2-2 flat in contact with IN718 pin as function of load. Fretting conditions: frequency, 80 Hz; slip amplitude, 50  $\mu\text{m}$ ; total number of cycles, 1 million; environment, air; and temperature, 550 °C.

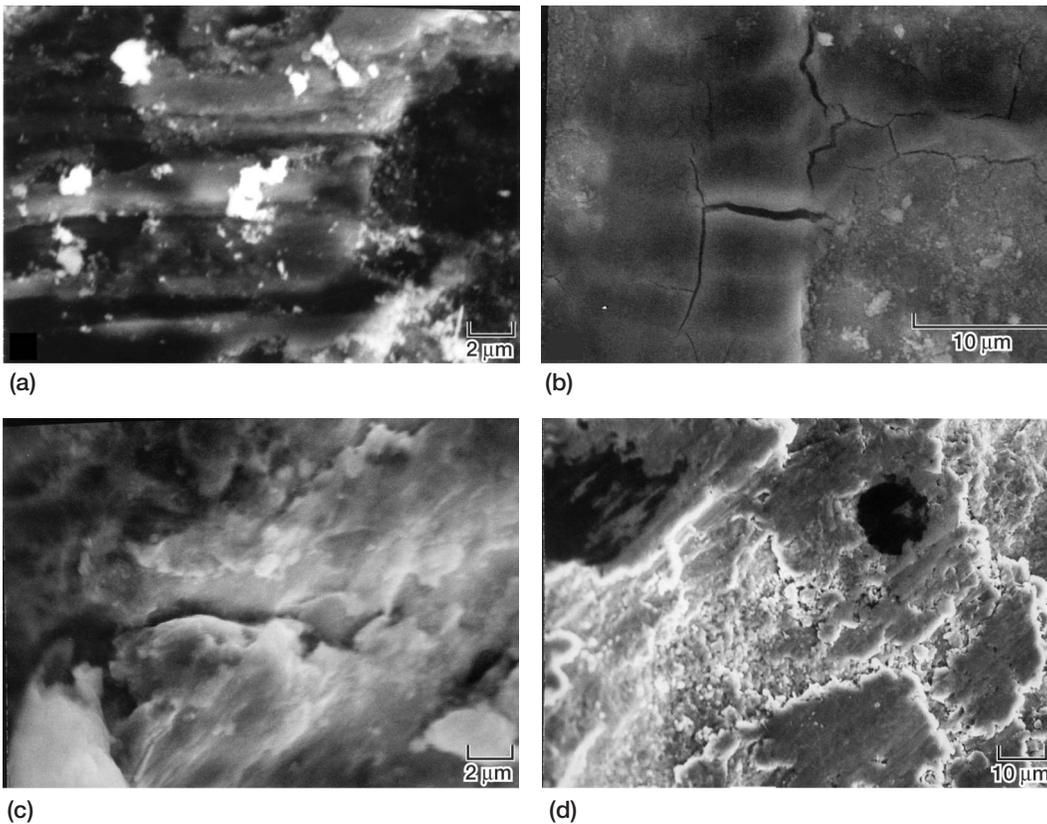
Figure 75.—Surface and subsurface damage in IN718 pin in contact with Ti-47-2-2 flat. Fretting conditions: load, 1 N; frequency, 80 Hz; slip amplitude, 50  $\mu\text{m}$ ; total number of cycles, 1 million; environment, air; and temperature, 550 °C. (a) Scratches. (b) and (c) Cracks in oxide layer.

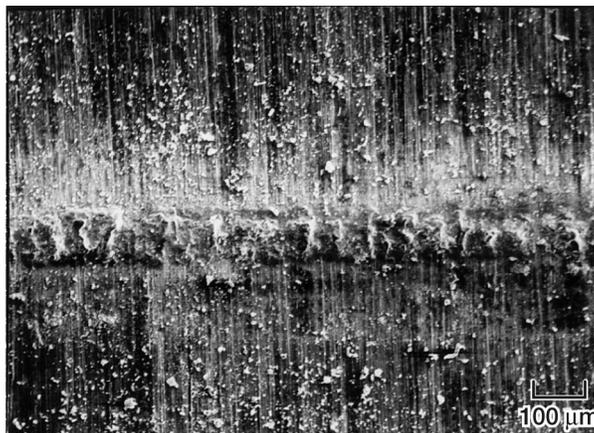
Figure 77.—Wear scar with wear debris produced on Ti-47-2-2 fatigue specimen in contact with IN718 contact pad. Fretting conditions (table III(b), for fretting on back side): load, 1.5 to 3.0 N; frequency, 80 Hz; slip amplitude, 50  $\mu\text{m}$ ; total number of cycles, 40 million; environment, air; and temperature, 550  $^{\circ}\text{C}$ .

contact area. Pieces of the  $\gamma$ -TiAl and its oxides are generally torn out or sheared off during fretting. Protective oxide layers readily form on both the  $\gamma$ -TiAl and IN718 at 550 °C in air. Cracks did occur in the oxide layers formed on the  $\gamma$ -TiAl and IN718 (figs. 78(a) and (b), respectively), and this limited the protection by these oxide layers. Figures 79(a) and (b) show examples of the  $\gamma$ -TiAl and IN718 surfaces that are torn out or sheared off during fretting. There are fractured pits, flakelike wear debris, and oxide wear particles in the contact areas of both the  $\gamma$ -TiAl and IN718 surfaces.

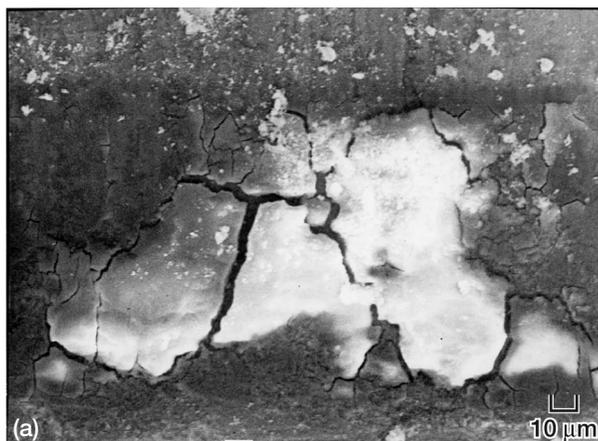
Figure 78.—Protective oxide layers produced on (a) Ti-47-2-2 fatigue specimen and (b) IN718 contact pad. Fretting conditions (table III(b), for fretting on back side): load, 1.5 to 3.0 N; frequency, 80 Hz; slip amplitude, 50  $\mu\text{m}$ ; total number of cycles, 40 million; environment, air; and temperature, 550  $^{\circ}\text{C}$ .

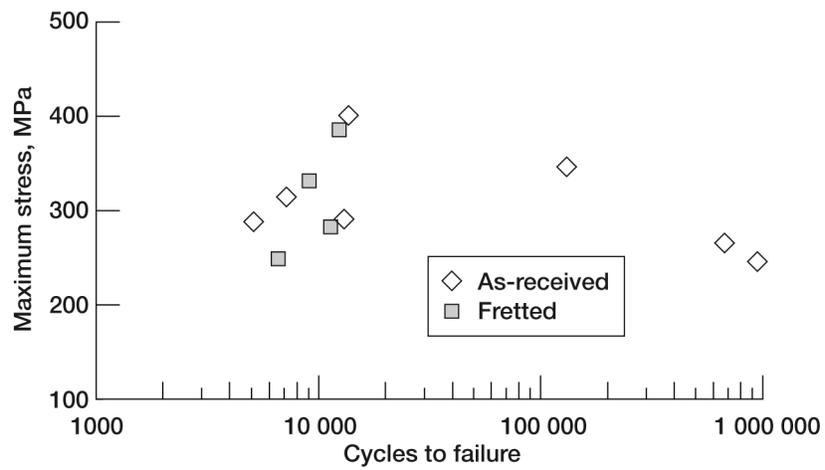
Figure 80.—Fatigue test results for both fretted and virgin, unfretted Ti-47-2-2 fatigue specimens.

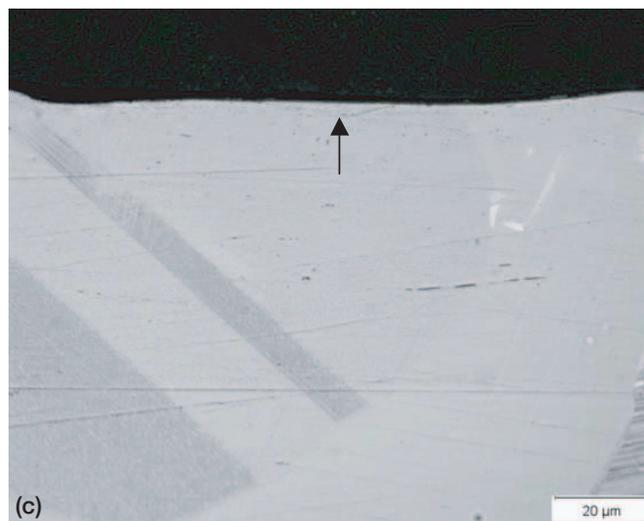
Figure 81.—Ti-47-2-2 fatigue sample 063-03-3. Arrows indicate fretted region. (a) Unetched. (b) Polarized. (c) Etched.
